RAN A4G Night ramp strike story — a series of notes and images, added over a year or so — explains various points about this event — 01 September 1971

Ramp Strike aboard HMAS Melbourne 01 Sept 1971 – Phil Thompson

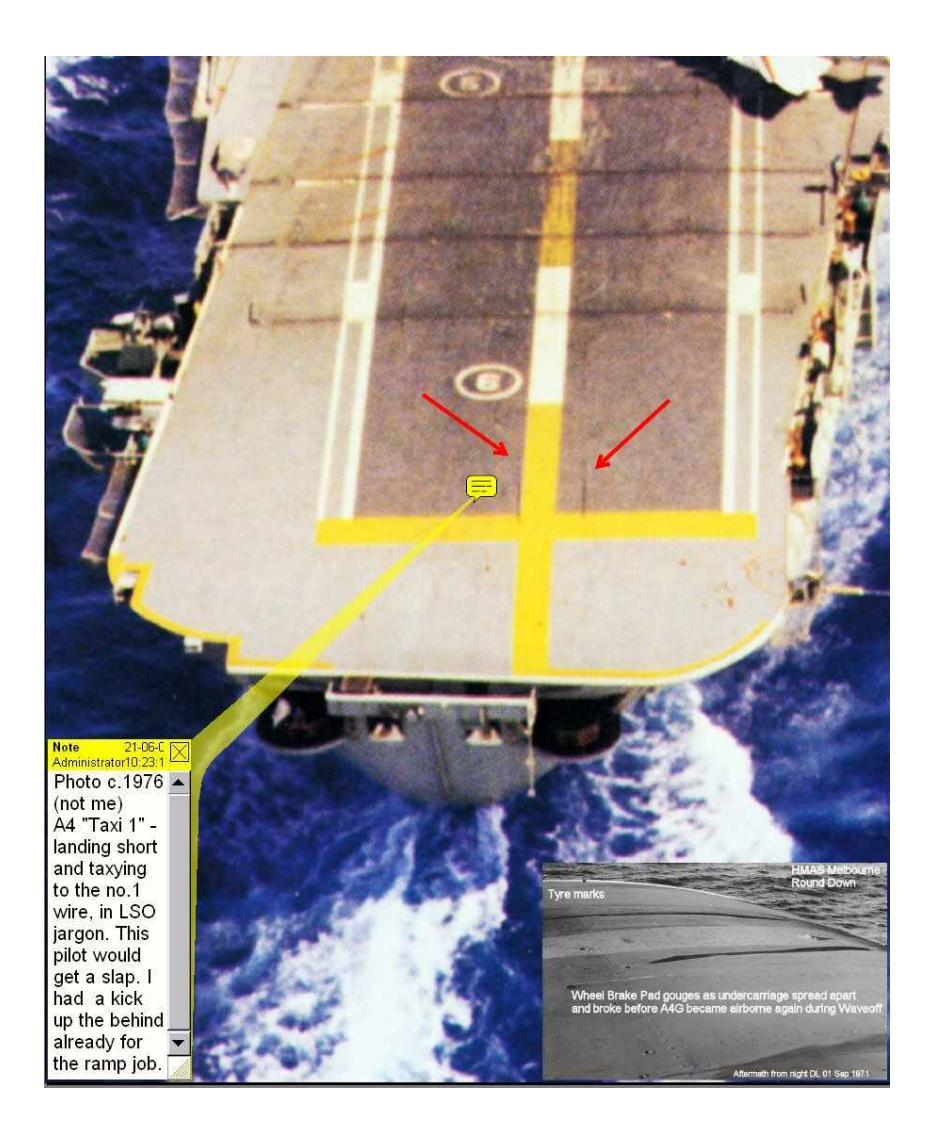
Of course there was an almighty bump as the wheels hit the deck and the U/C flexed so much that the inner brakes gouged the steel deck before the U/C broke — but I was going UP at the time — if I had still be going down it would have been all over. Thank goodness for relative motion etc. Photo of ramp damage + diagram

Later I heard about what this event looked like from those on the ship. They said the shower of sparks was amazing, as the steel met steel. I was lucky also that the undercarriage leg stubs did not catch a wire, that would have been catastrophic. So I was airborne again before reaching the No. 1 wire. You can see on the photo how the black tyre marks start/stop and the gouges of the brake mechanism (inside the wheel) on the steel deck (before it broke, along with everything else related to the U/C). [Later I was told that paint marks from the drop tank fins were on the deck but painted over quickly - so I never saw them myself.]

As mentioned on the ADF site, it was a year before the A4 could be mended with a permanent (acceptable) bend in the airframe. I recall I was supposed to take it on the first (squadron) test flight, but this flight was cancelled due to bad weather and subsequently someone else took it up.

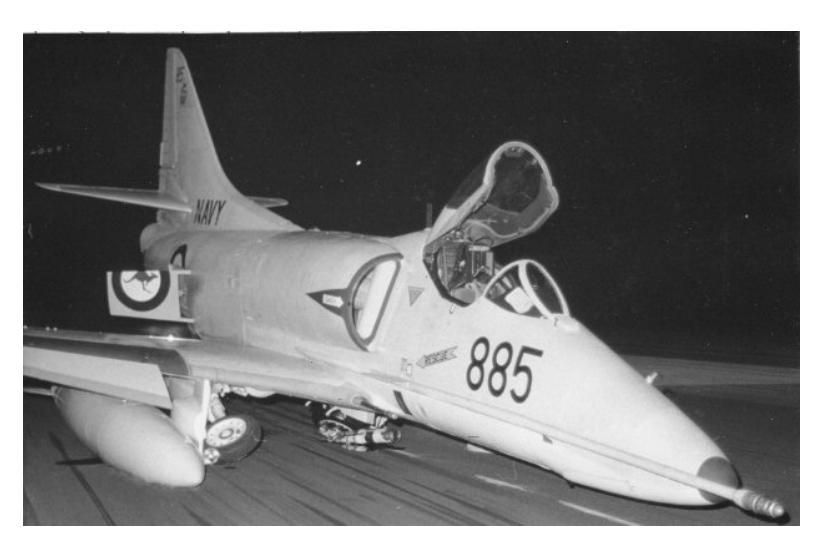
Aftermath from night DL 01 Sep 1971

Tyre marks

HMAS Melbourne Round Down

Wheel Brake Pad gouges as undercarriage spread apart and broke before A4G became airborne again during Waveoff

Further up the deck were twin paint marks from the drop tank fins scraping the deck. The tanks were not breached though. The marks stopped before No.1 wire though.

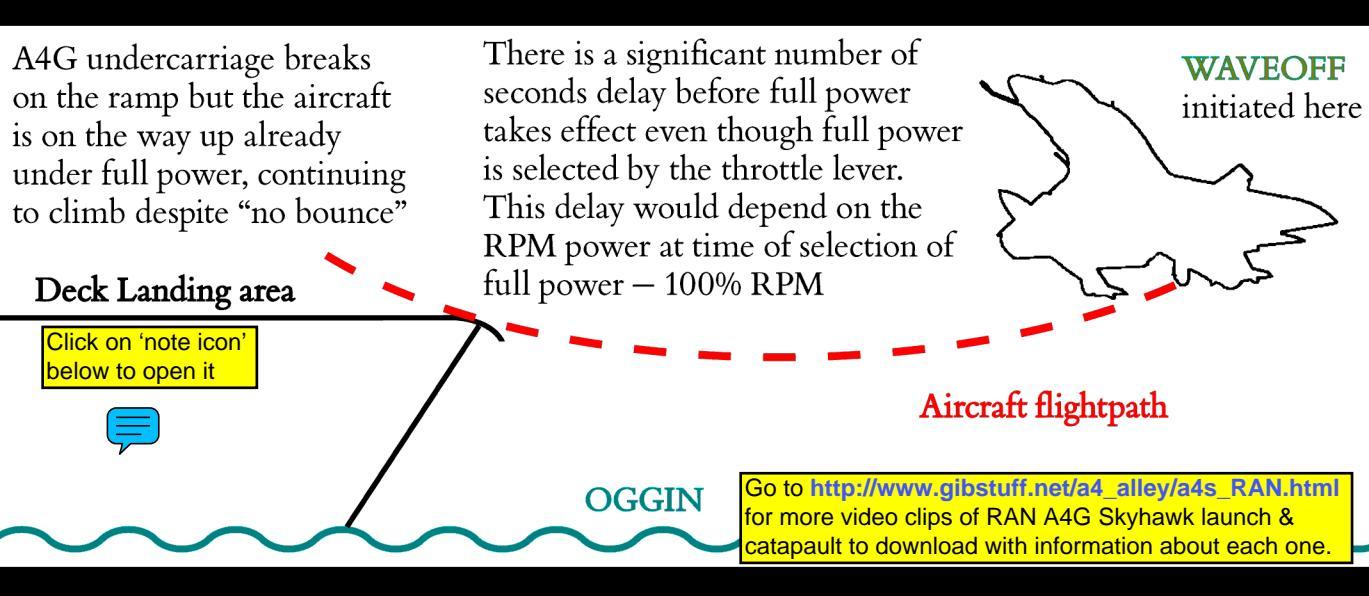
During the work up of HMAS Melbourne and her squadrons an incident occurred during a night landing which demonstrated the rugged qualities of the A4 Skyhawk. The aircraft got low on its final approach and broke a main undercarriage leg but was able to overshoot. An attempt to land on board would only have added further hazard, accordingly the aircraft was diverted for an airfield landing.

The aircraft was fitted with a drop tank on each wing attached to what is referred to as a "hard point". These points proved to be just that! The tanks being empty it was decided to lay a carpet of foam in the touchdown area just beyond the liss arrester gear, and talk the pilot down to an arrested landing, with the remaining undercarriage legs retracted. While the foam was being laid an experienced Landing Signal's Officer briefed the pilot on all contingencies to expect during the approach and landing. The aircraft caught the arrester gear and the drop tanks absorbed all of the impact. The underside of the aircraft did not contact the runway, and the subsequent repairs included the drilling out and replacement of some 270 sprung rivets, together with a new undercarriage leg. The aircraft was then returned to service.
