RAN A4G Night ramp strike story — a series of notes and images, added over a year or so — explains various points about this event — 01 September 1971

Ramp Strike aboard HMAS Melbourne 01 Sept 1971 – Phil Thompson

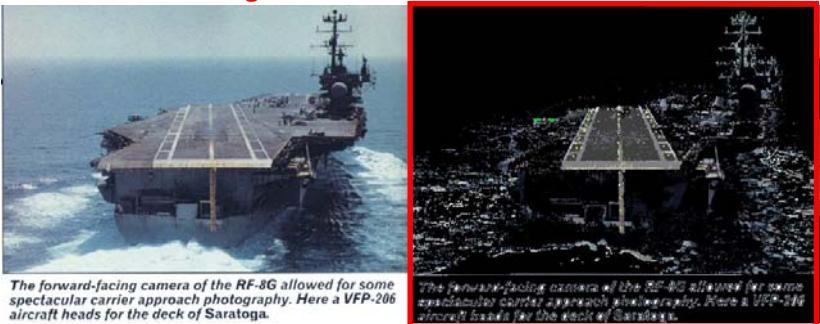
The image is taken from a reconnaissance RF-8 Crusader approaching a big USN carrier. In this view you can see the orange ball between the green datum lights. The orange ball is slightly high but this may be a factor of where the camera is in relation to the pilot's eyeline. So for the pilot view his is likely "in the groove" with the orange ball in the middle of the datum lights. BTW the orange ball moves vertically to show the pilot where he is in relation to the glideslope. So when the ball is above the line of green lights — the pilot is above the ideal glideslope and vice versa.

To add one further note about my own lucky escape. The ramp was moving as explained, usually it does so in a regular cycle with the sea state. Why I saw the ramp much higher was that the sea had given it a kick out of cycle, then by the time I got there to hit it, the ramp was most likely at the lowest point in its cycle and was probably just going up again. This helped me survive. There were not many knowledgeable (SEs & LSOs) witnesses to confirm this, as quite rightly, they were diving for cover. Ouch. So this is just my guesstimate. At the time I hit I was not "spotting the deck" (looking at the deck, as this would have been fatal). But I was concentrating on climbing at the best OAO, getting the best climb angle and rate of climb to get out of that black hole (this meant that the deck was no longer in view due to the exaggerated climb angle). So many factors combined to get me out of my (very own bad) catastrophic approach.

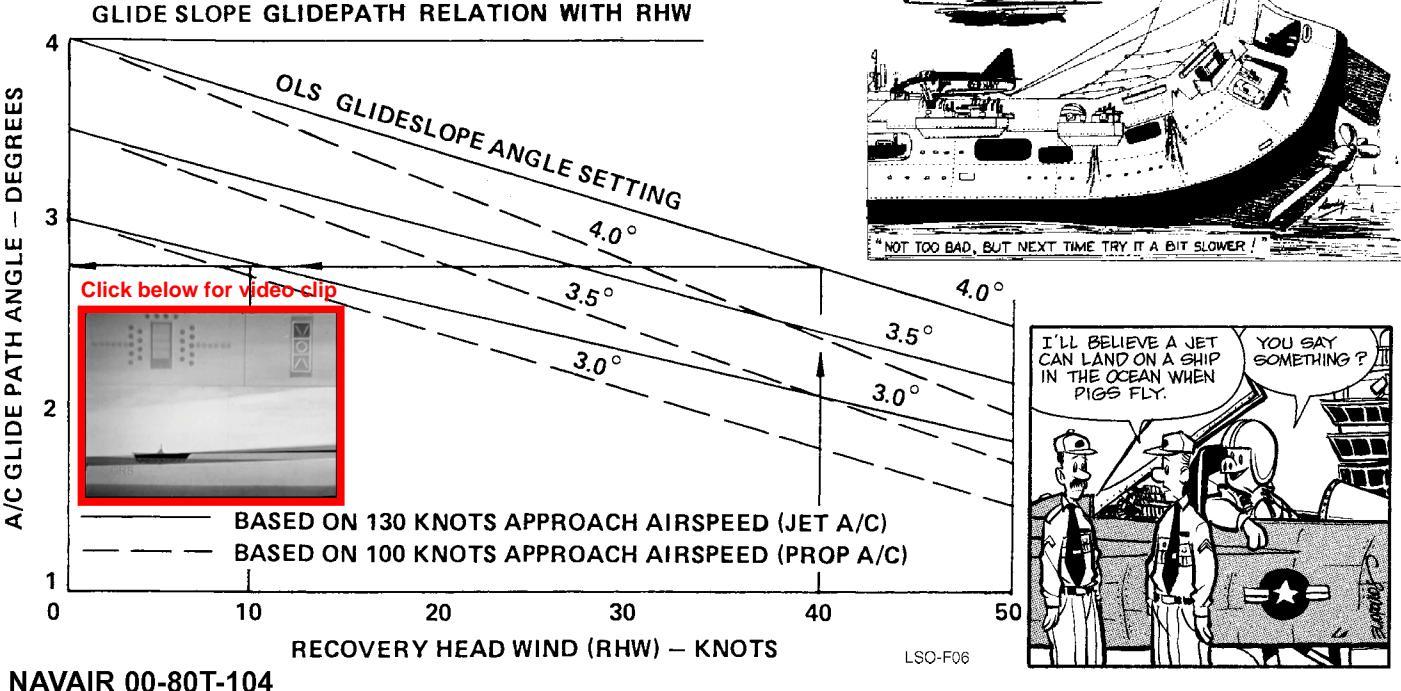
Figure 4-7. Glideslope Glidepath Relation with RHW

4.2.7 Effective Glideslope Due to Wind and Deck Motion. The glideslope angle, referred to as the basic angle aboard ship, is the fixed pitch angle around which the lens assembly stabilizes. A basic angle setting of 3.5° is most commonly used, with 4° used for higher wind-over-deck conditions (38+ knots) or on the small decks when hook-to-ramp clearance is near the 10-foot minimum. In moderate wind-over-deck conditions (32 to 37 knots), a 3.75° basic angle may be desirable. In Figure 4-7, note that decreased closure rate of aircraft to ship caused by wind-over-deck reduces the actual glideslope flown (effective glideslope).

Aircraft landing stress limits are predicated on moderate deck conditions. Extreme deck motion may significantly increase these landing stresses; the ramp coming up at touchdown increases relative sink rate. Additionally, 1° of ramp down is the same as adding 1° to the glideslope as far as aircraft landing stresses are concerned. These deck motion factors are among the most critical to consider when landing aircraft on carriers.
